CONSOLIDATED DIKING IMPROVEMENT DISTRICT NO. 1

MAIN PUMP STATION BRIDGE REPAIRS

To: Troy Cole
From: Samuel Lozano PE
Copies: File
Date: November 12, 2025
Subject: CDID Main Pumphouse Concrete Bridge Rating
Project No.: 22123

To: Troy Cole
From: Samuel Lozano PE
Copies: File
Date: November 12, 2025
Subject: CDID Main Pumphouse Timber Bridge Rating
Project No.: 22123

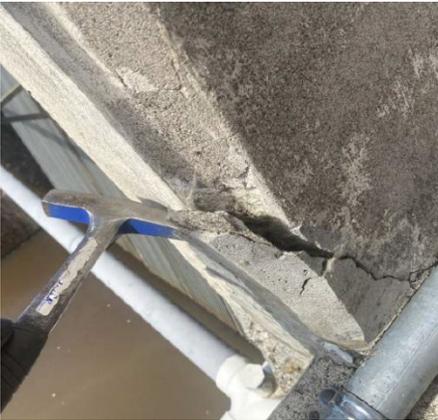
<p>2nd post, north end, west side: Failed patch</p> <p>Remove loose and delaminated grout down to sound concrete. Brush and clean all surfaces prior to patching. Apply bonding agent and use high-strength non-shrink precision grout.</p>

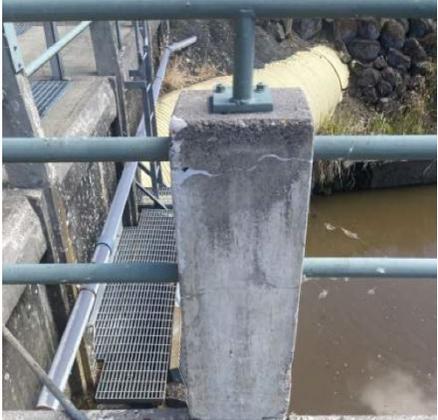
<p>1st post, north end, east side: Failed patch approximately 4-inches deep x 2 SF</p> <p>Remove failed patch and spalling concrete down to sound concrete. Brush and clean all surfaces prior to patching. Apply bonding agent and use high-strength non-shrink precision grout. Hand trowel and chamfer corners to match existing edges.</p>

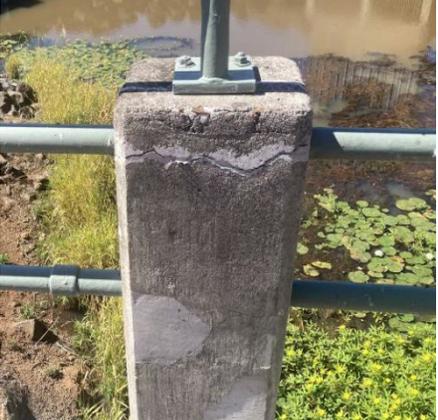
<p>5th post, mid span, west side: Delaminated patch</p> <p>Remove loose and delaminated grout down to sound concrete. Brush and clean all surfaces prior to patching. Apply bonding agent and use high-strength non-shrink precision grout.</p>

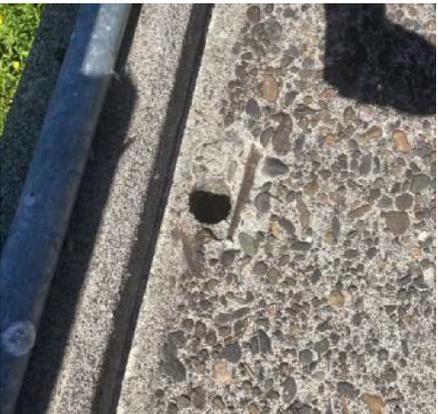
<p>Bridge deck, south end, west side: Exposed rebar, approximately 6-inches long</p> <p>Sawcut on both sides of rebar to provide clean edges. Remove surrounding and underlying concrete by 1-inch in all directions. <u>Do not cut rebar.</u> Wire brush rebar to remove rust and coat with epoxy primer. Blow out with compressed air or vacuum clean. Use high-strength non-shrink grout. Do not fill adjacent hole.</p>

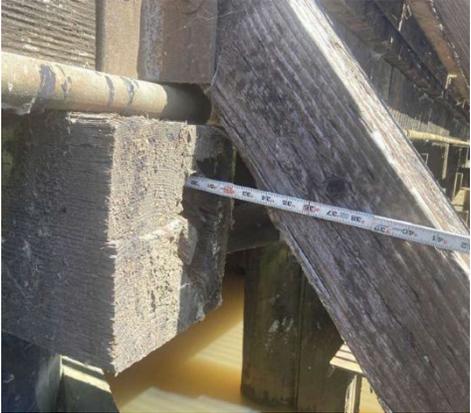
<p>Pile cap, Bent 3, south side: Rotted end</p> <p>Existing pile cap is two pieces. Install temporary supports as needed to take weight off one-half of the pile cap. Remove and replace with treated Doug Fir-Larch No. 1, 10"x10"x 10'-3" long to match existing. Re-attach steel strapping to secure the pile cap to the pile supports.</p>

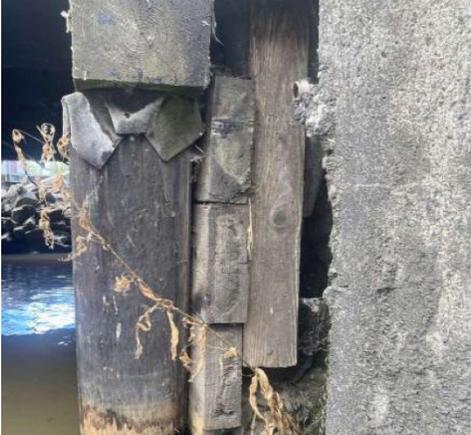
<p>West abutment, northwest corner: Material void</p> <p>Pressure grout fill a large cavity behind the backwall where the timber bridge meets the end of the concrete retaining wall. Use soil stabilizing expanding grout to fill voids and annular spaces within the soil. Use two-step Avanti Low Vis Hydro moisture activated polyurethane resin AV-278 mixed with Low Vis Accel catalyst AV-279. Approximately 1 CY.</p>

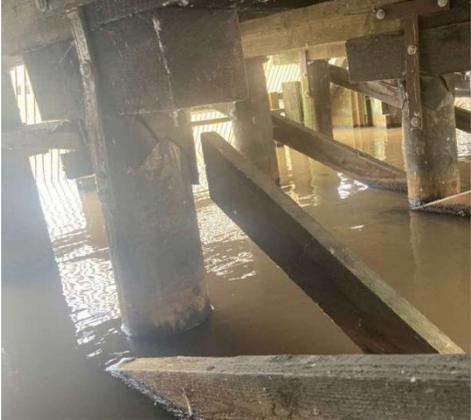
<p>Multiple bents: Loose cross bracing</p> <p>Re-attached existing 2x8 cross bracing to piles. Use exterior grade timber screw fasteners, 8" long.</p>

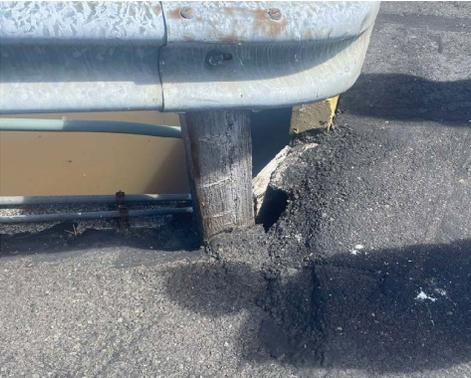
<p>West abutment, north side: Deficient drainage</p> <p>Install asphalt patch with built-up curb to redirect water runoff away from the bridge abutment and toward the bridge deck. Add rock and supporting material below as needed to build up unsupported corner of asphalt, approximately 3/4 CY.</p>

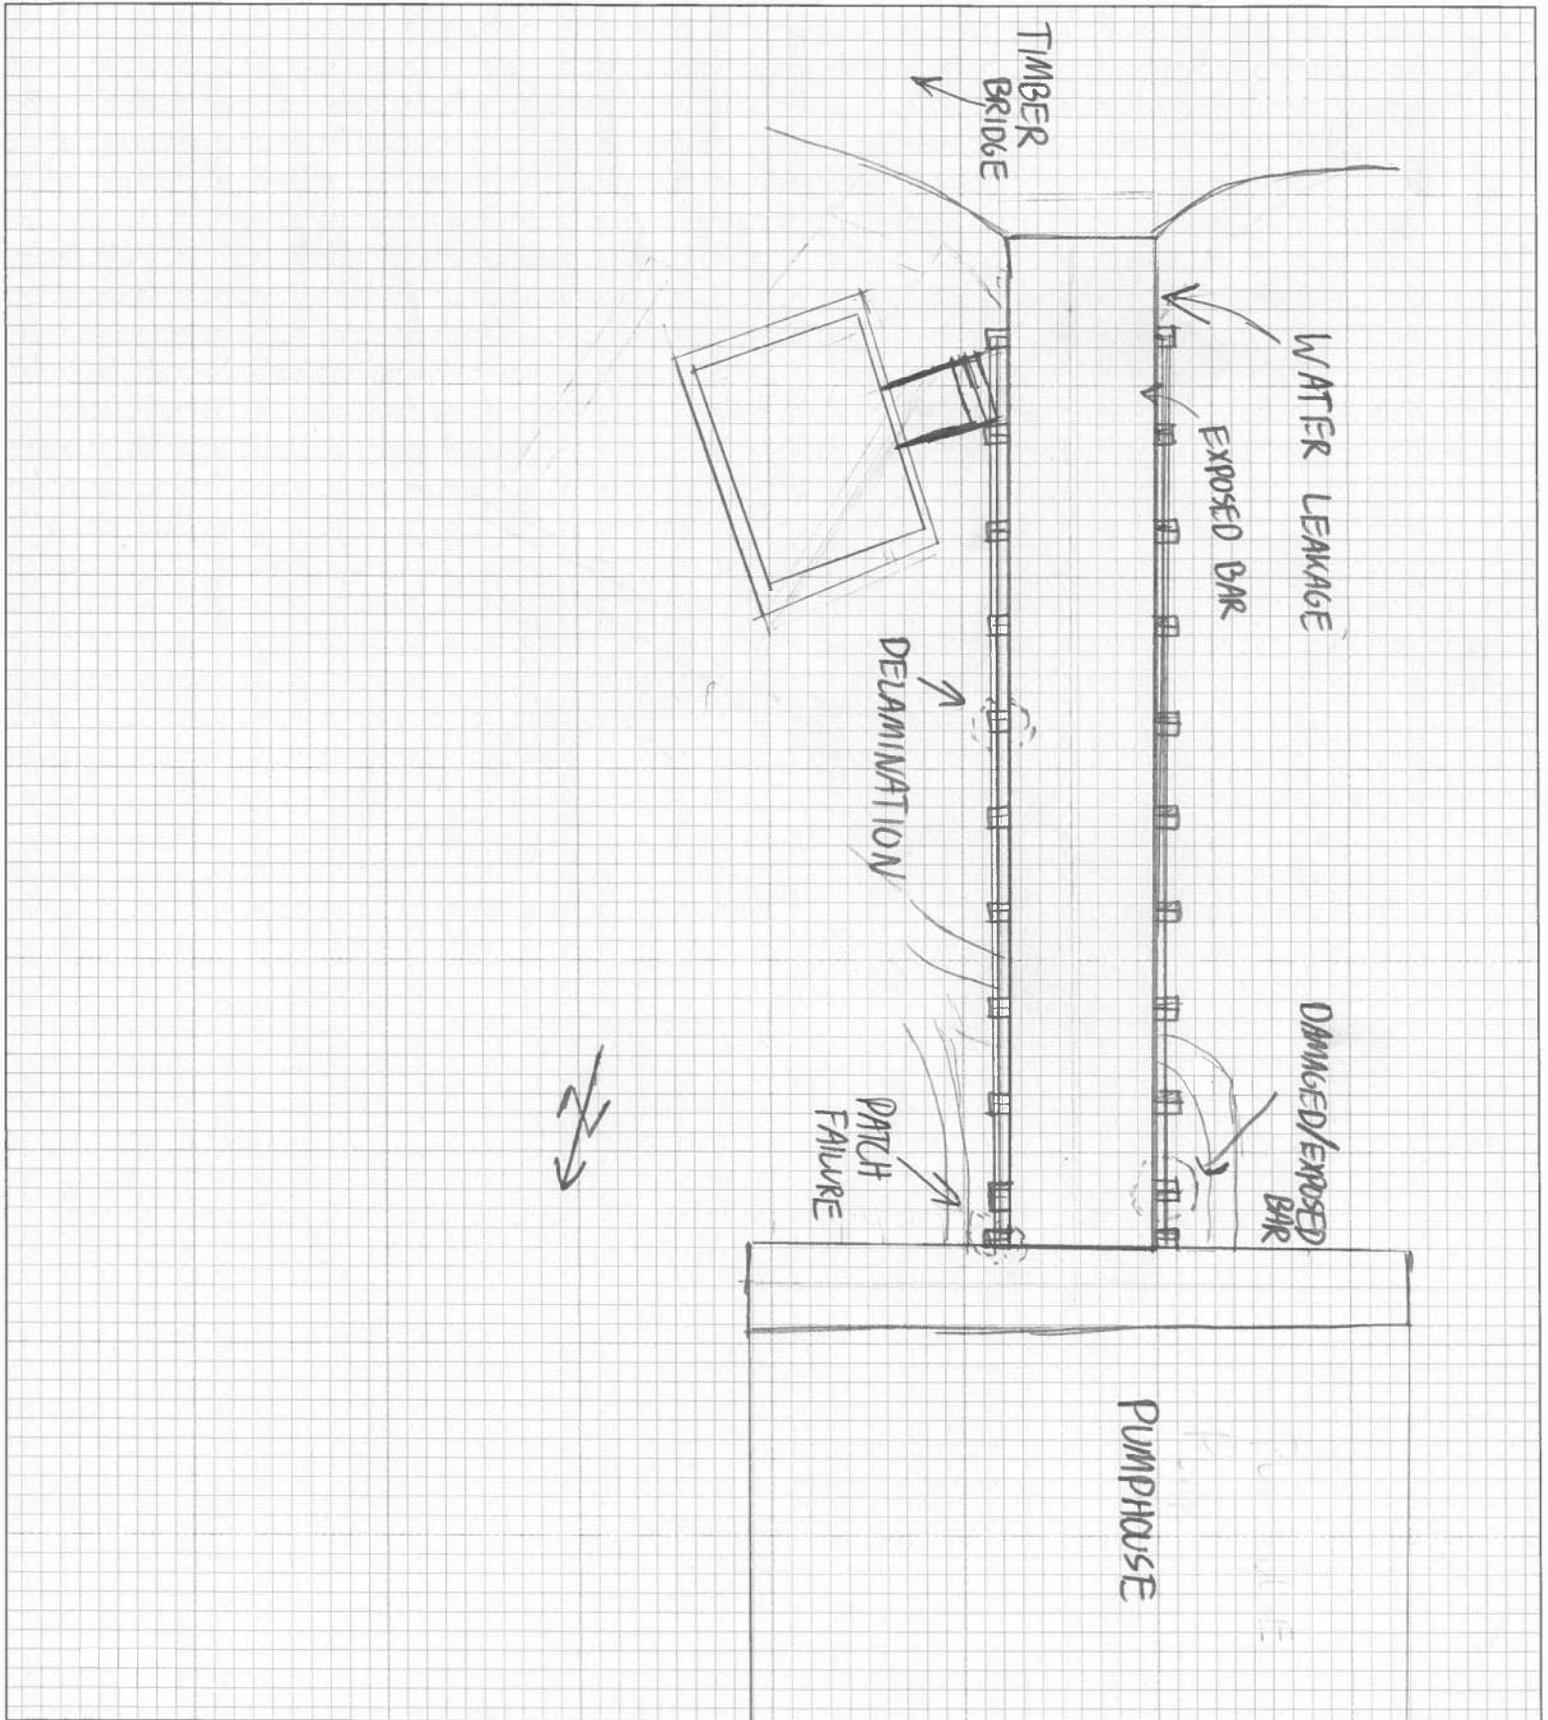
project CDIP - Concrete Bridge job# 22123 date 09/10 by NC

The concrete bridge deck overlay was in satisfactory condition, with 6" inches of exposed rebar on the north end of bridge near 2nd rail post from west side. Localized delamination was detected at several places below the deck. In two places, the alignment of the large pipes used to replace the spillway system required removal of some material from the substructure.

The railings and curbs were in fair condition, with multiple instances of spalling, delamination, and patch failure. On the west side of the north end of the bridge, the second post exhibited significant delamination. On the east side of the bridge, the concrete rail on the north side exhibits spalling due to a patch failure approximately 2 square feet in area and up to 4 inches deep. The south side rail shows delamination near

mid-span (fifth post from the east end). On the west side, previous water leakage beneath the pipe has eroded the concrete surface down to exposed aggregate. Additionally, several patched rail posts display early signs of delamination and spalling. Estimated of 24 square feet of delaminated surface for concrete rail posts.

We recommend patching areas on spalled and delaminated concrete on the deck surface and rail posts. Material should be removed down to sound concrete and any exposed rebar should be brushed and cleaned to ensure no loose material prior to patching. There is an estimated 24 S.F. of delaminated and spalled concrete surface on the rail posts, varying in depth up to 4 inches.

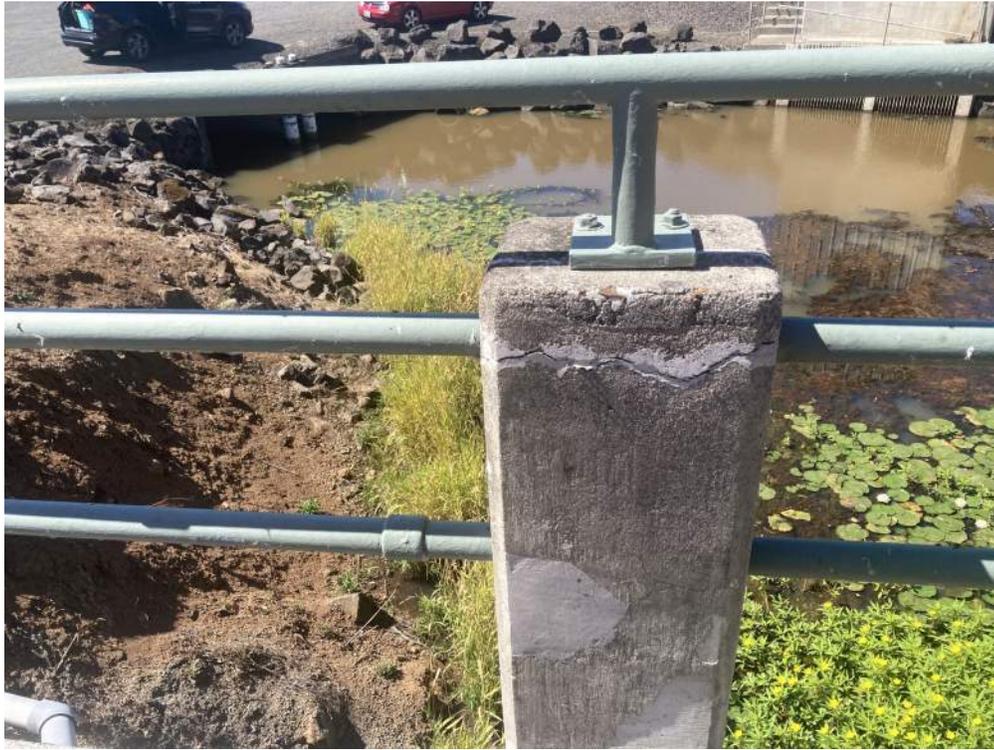
Damaged patch repair on barrier around mispan, west side

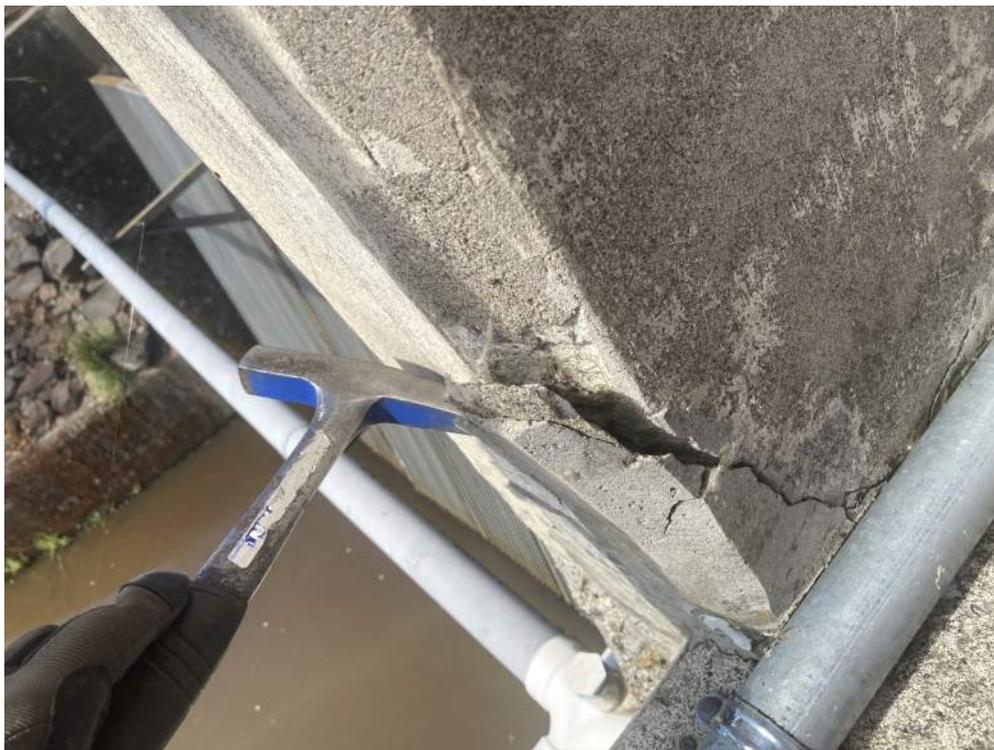
View of delamination of barrier on Northwest side (Second post on north end, west side)

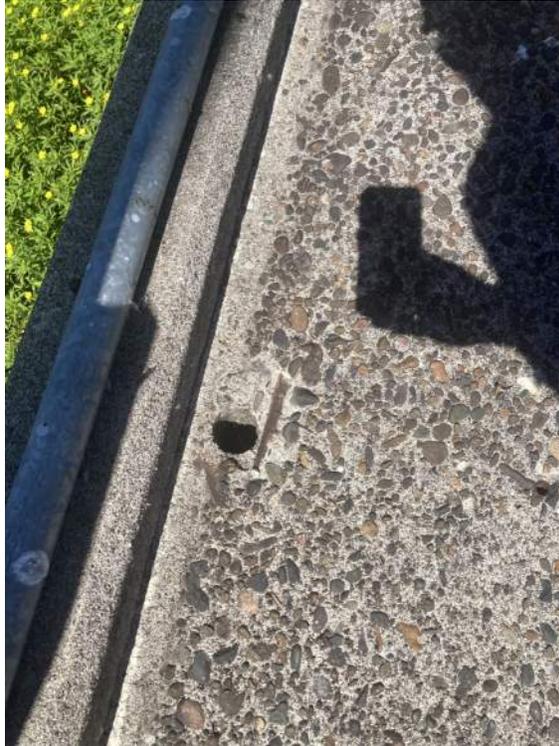
View of exposed rebar on west side of bridge near south end of bridge

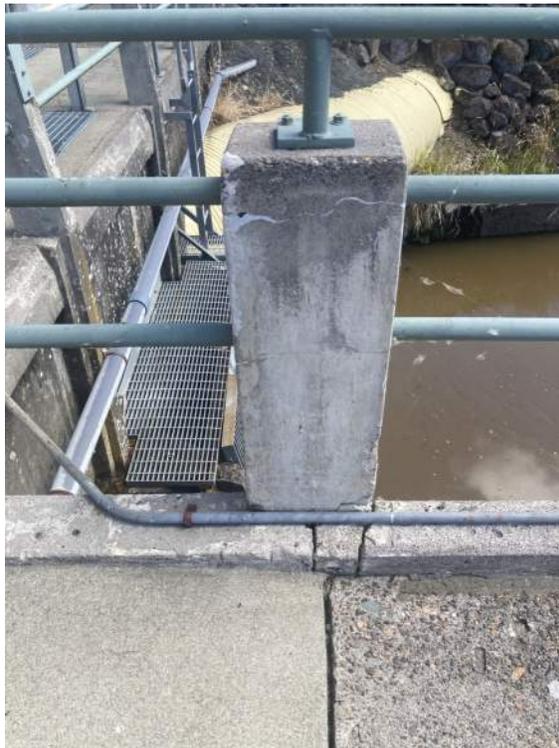
View of spalling on barrier (First post on north end, east side)

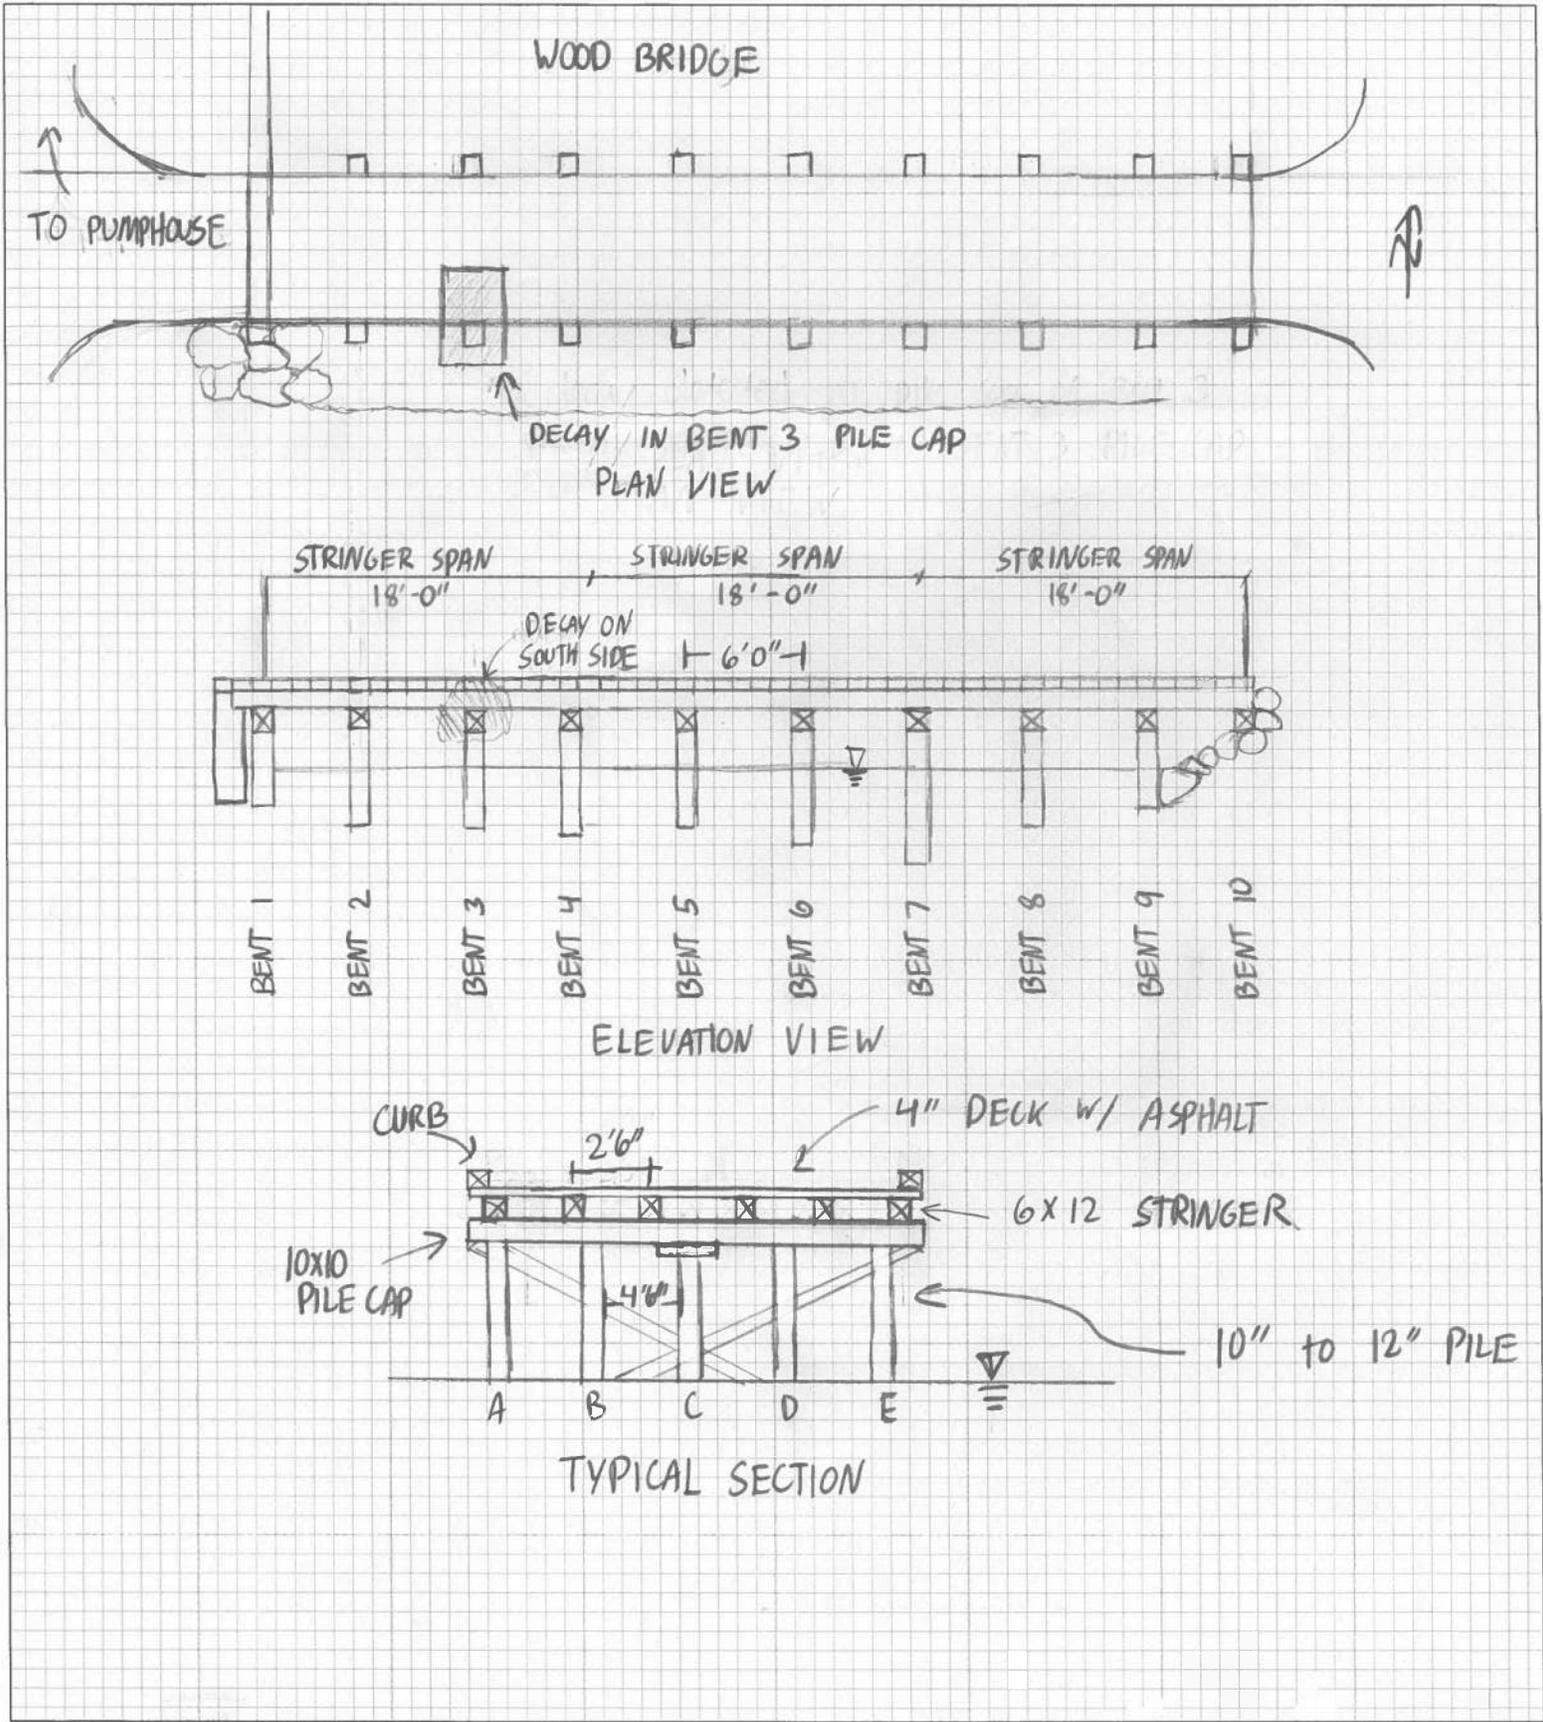
project CD10 Timber Bridge job# 22123 date 09/10/25 by NC

Pile caps were in good to poor condition. Several caps appeared to be recently replaced, and the majority had small amounts of rot on the exposed end grain. The cap on the south side of Bent 3 (third from the west end) was in poor condition with extensive rot and decay from the end to approximately 3 feet in, extending over the bearing on Pile E. No significant distress of the structure at this location was observed under light vehicular loading.

The west abutment backwall was in poor condition. No rot was detected in the timbers themselves but a large void was present at the northwest corner behind the backwall where the timber bridge meets the end of the concrete retaining wall coming off the concrete bridge. The void appears to have been caused by drainage off the concrete bridge and the relatively steep approach being directed to this corner and eroding the soil behind the backwall into the pond. A small amount of asphalt at this corner is unsupported from below but is well outside the normal wheel path and is unlikely to take any significant loading.

Immediate priority recommended repairs for the bridge are to replace the section of rotted pile cap at Bent 3 and to redirect drainage away from the northwest corner to prevent further erosion behind the backwall. Replacement timber should be treated DFL (Doug Fir-Larch) No. 1 or better to match existing size.

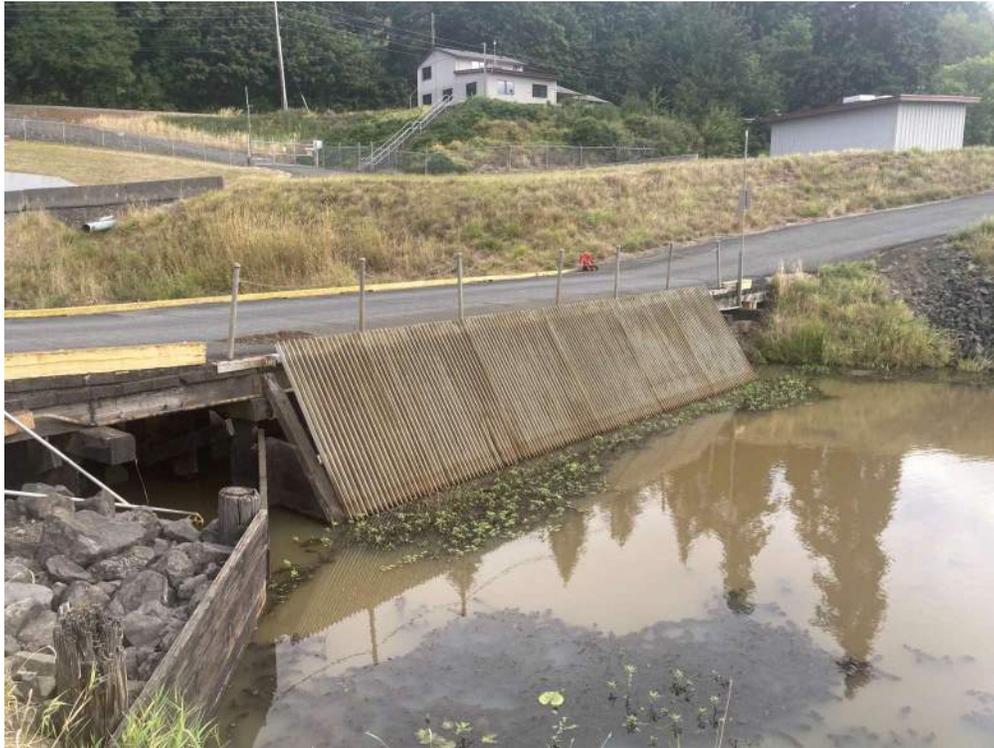
Photo #3
View of West Abutment

To direct water away from the northwest corner either a short curb built-up with asphalt or a commercially available bolt-down rubber curb would be sufficient, provided it can be sealed along the bottom to prevent water movement. Given the tight grading constraints at the site the drainage would likely have to be

If it is desired for the void to be filled for a permanent repair, high-pressure grout injection would be required behind the backwall. This should be considered an optional and lower priority repair than redirecting the existing flow of water away from this area.

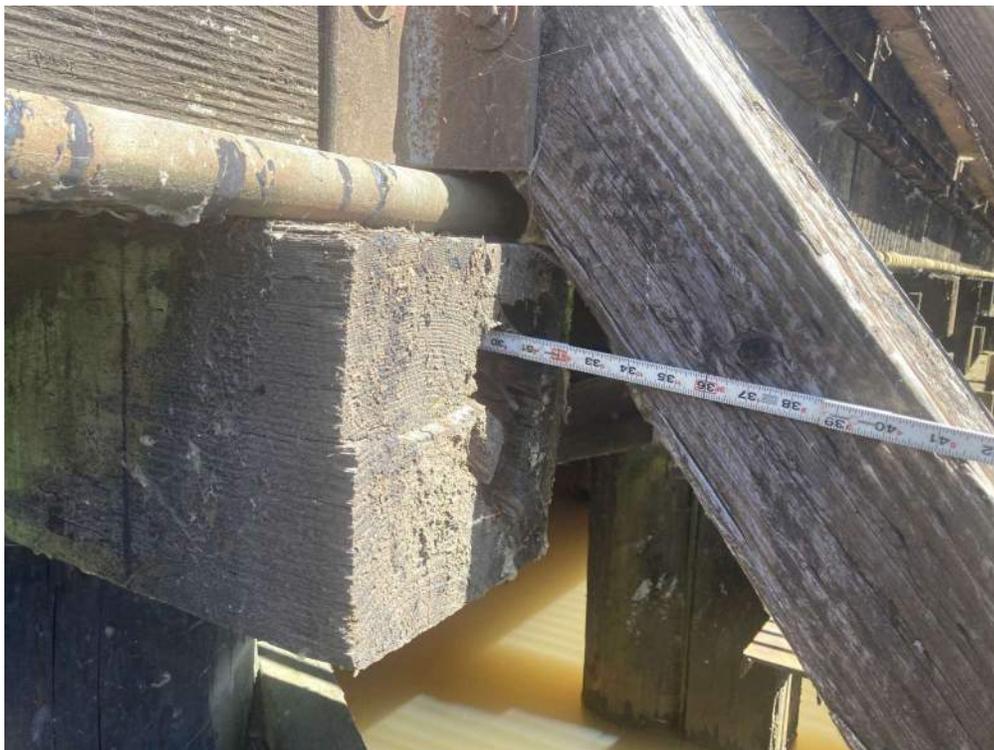
The decay to the pile cap at Bent 3 is likely causing a reduction to the load carrying capacity of the bridge and if left unrepaired would necessitate a revision to the load rating. If the pile cap section is replaced in kind and no other alterations are made to the structure then the structure can be safely assumed to have the same load carrying capacity and no revisions to the load rating are necessary.

Photo #4
View of end rot on Bent 3 Pile Cap

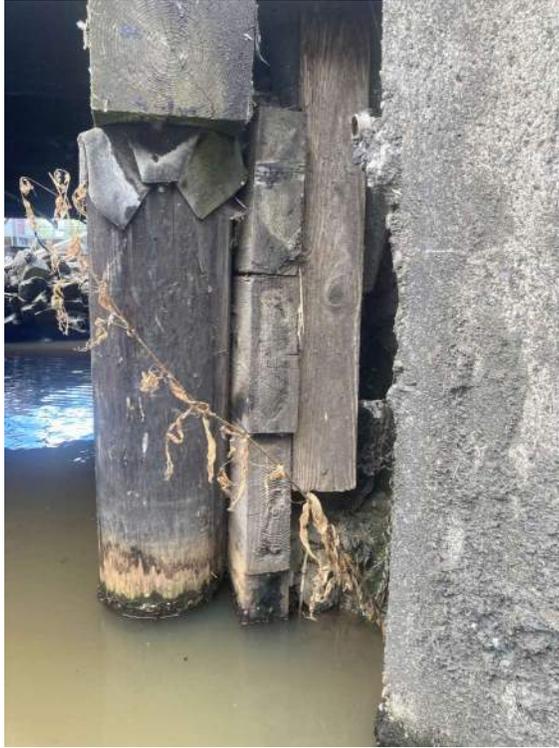
The existing void should be monitored for further erosion or collapse of material into the existing void, which would likely be detectable through cracking of the asphalt and/or settlement of the roadway. Given the layout and usage of the roadway this would be unlikely to cause an immediate safety issue and additional asphalt could be placed to bring the roadway back up to grade.

Photo #5
View of cavity caused from erosion on backside of West Abutment
