CONSOLIDATED DIKING IMPROVEMENT DISTRICT NO. 1

MAIN PUMP STATION BRIDGE REPAIRS

To: Troy Cole
From: Samuel Lozano PE
Copies: File
Date: November 12, 2025
Subject: CDID Main Pumphouse Concrete Bridge Rating
Project No.: 22123

To: Troy Cole
From: Samuel Lozano PE
Copies: File
Date: November 12, 2025
Subject: CDID Main Pumphouse Timber Bridge Rating
Project No.: 22123

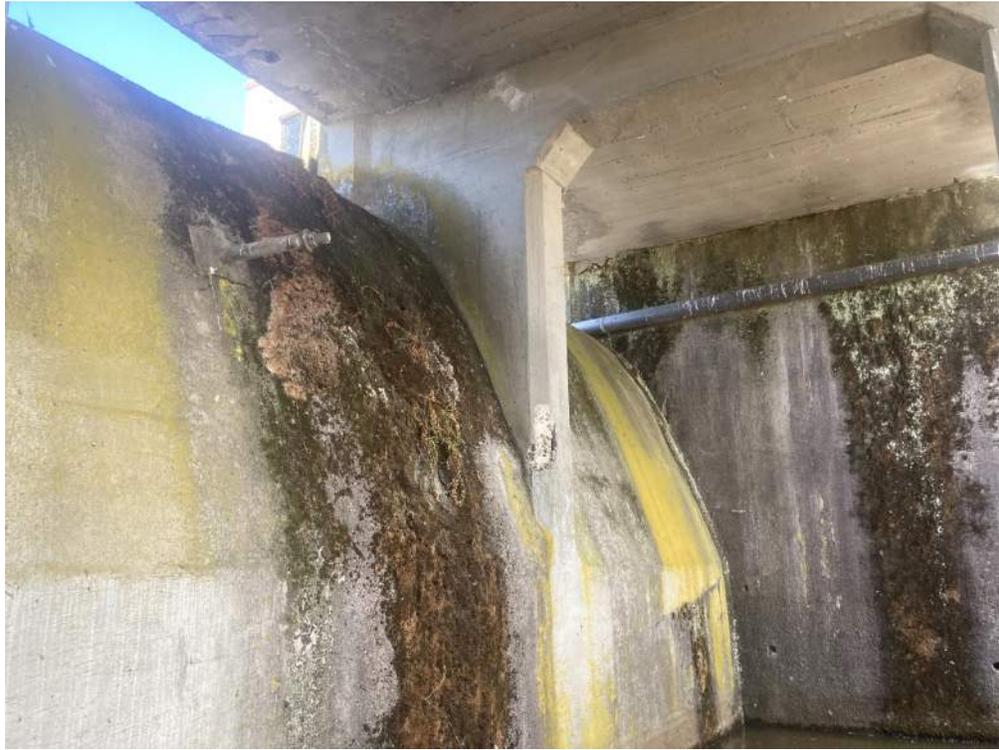
The deck soffit was well above water elevation and assessed visibly, no significant deterioration was observed.

Typical view of underside of bridge
